COMMUNITY INVOLVEMENT PLAN

**LONG TERM MONITORING PHASE FOR THE
INSTALLATION RESTORATION PROGRAM**

UNITED STATES MILITARY ACADEMY

FEBRUARY 2004

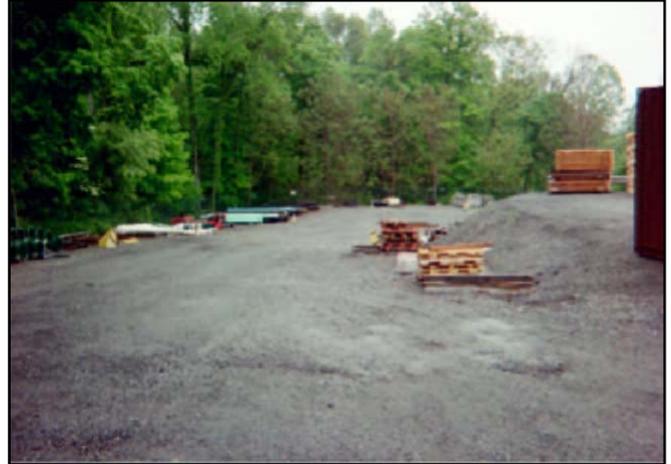
The Organic Compost Landfill, was part of the 6 Landfill Investigation Report and is located northwest of Building 743; access is from Garrard Road. This 0.5 acre landfill was used in the 1960s for disposal of construction debris. More recently, the site had been used for composting of organic material including leaves, mulch, tree limbs and grass cuttings. The landfill is closed and currently used as a lumber storage yard. The landfill cover was tarred and chipped. The landfill is scheduled to be surfaced with asphalt in FY04. Although leachate seeps have been identified at this site in the past, recent engineering inspections have detected no seeps.

A leachate tank was installed at the site. The Organic Compost Landfill has been included in USMA's Sampling and Analysis Plan for LTM and maintenance and groundwater sampling is conducted at this site.

LTM and cap maintenance will continue. In FY06, USMA will propose to regulators to reduce sampling frequency to every five years.

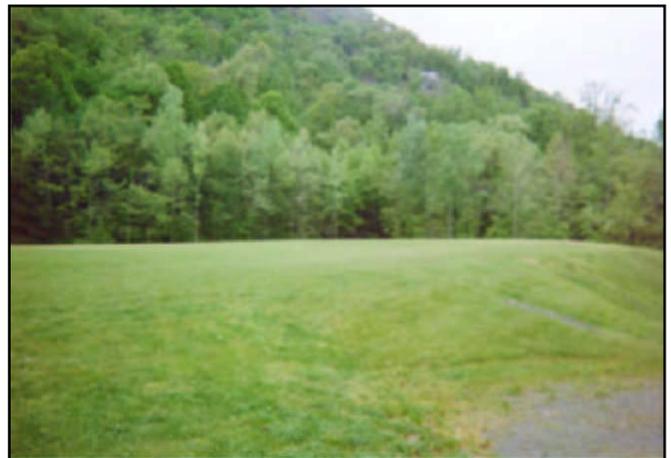
The Post School Landfill, which was part of the 6 Landfill Investigation Report, is located adjacent to the West Point Elementary School. Access is from the school parking lot or Barry Road. This 2.5-acre landfill was used approximately from 1964 - 1969. The pit and area methods were used. The landfill is closed and vegetated. The site was used as a playing field for the school and youth activities center. Although leachate seeps have been identified at this site in the past, recent engineering inspections have detected no seeps.

A leachate collection tank has been installed and upgraded. Sediments in an adjacent stream have been discolored by leachate. Differential settling and poor drainage have made the field unusable. The perimeter drainage swale and leachate collection system have been upgraded as an interim remedial action. A cap and drainage improvement design was finalized in FY97 and implemented in FY98. The Post School Landfill has been included in USMA's Sampling and Analysis Plan for LTM and maintenance is conducted at this site.

LTM and cap maintenance will continue. In FY06, USMA will propose to regulators to reduce sampling frequency to every five years.

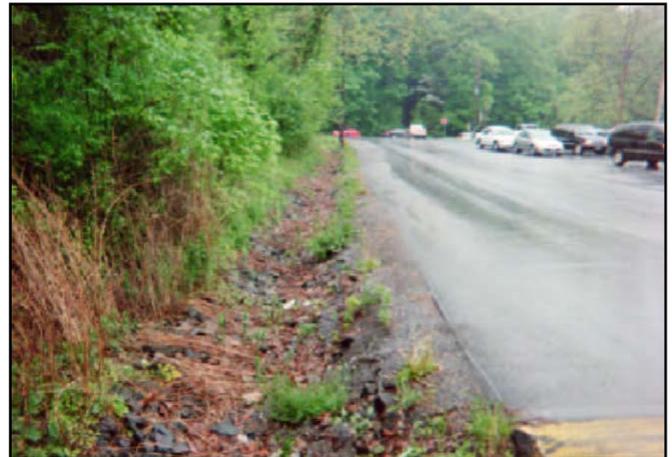
The Ski Slope Landfill, which was part of the 6 Landfill Investigation Report, is located adjacent to the ski lodge; access is from NYS Route 218. This 0.7-acre landfill was used approximately between 1965 and 1974. The pit and area methods were used for disposal of sanitary and construction wastes. The landfill is closed and paved. The site is now used as a parking lot. Although leachate seeps have been identified at this site in the past, recent engineering inspections have detected no seeps.

Sediments in an adjacent stream have been discolored by leachate. A cap and drainage system improvements were constructed and completed in FY01. The Ski Slope Landfill has been included in USMA's Sampling and Analysis Plan for LTM and maintenance and groundwater sampling is conducted at this site.

LTM and cap maintenance will continue. In FY06, USMA will propose to regulators to reduce sampling frequency to every five years.

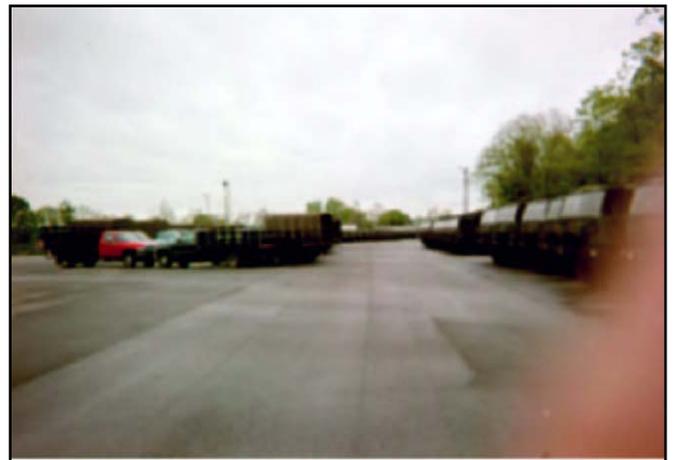
The Motor Pool Landfill, which was part of the 6 Landfill Investigation Report, is located east of the Motor Pool fuel distribution system; access is from Reynolds Road. This 4.5-acre landfill was used approximately from 1964 - 1969. The pit and fill method was used for disposal of sanitary refuse. The landfill is now used as a parking lot for motorpool vehicles. In FY99, the cap was enhanced and drainage controls were installed.

Leachate seeps have been identified at this site in the past. A leachate collection system was installed in FY01 to remedy a seep downgradient of the landfill. Recent engineering inspections have identified that the seep in the vicinity of monitoring well 95LS-02 has increased and additional investigation into the source of the seep was performed in FY03. The Motor Pool Landfill has been included in USMA's Sampling and Analysis Plan for LTM and maintenance and groundwater sampling is conducted at this site.

LTM and cap maintenance will continue. In FY06, USMA will propose to regulators to reduce sampling frequency to every five years.

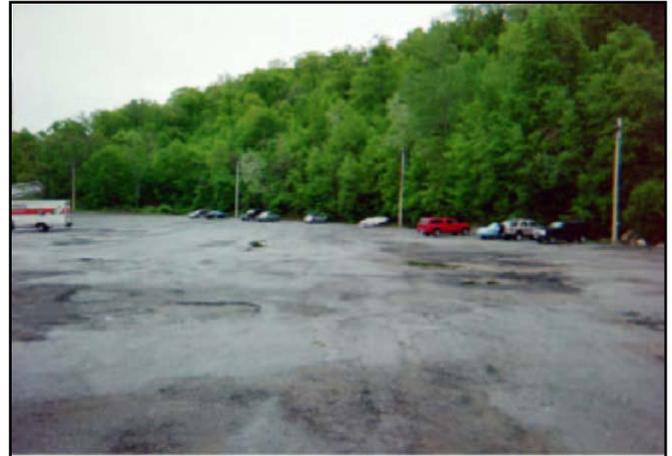
The Michie Stadium Lot D Landfill, which was part of the 6 Landfill Investigation Report, is located west of Michie Stadium; access is from Stony Lonesome Road. This two-acre landfill was active between 1956 and 1958. The pit and trench methods were used. The site is now used as a parking lot. The landfill is scheduled to be resurfaced in FY04. A perimeter drain has been installed. Although leachate seeps have been identified at this site in the past, recent engineering inspections have detected no seeps. The Michie Stadium Lot D Landfill has been included in USMA's Sampling and Analysis Plan for LTM and maintenance and groundwater sampling is conducted at this site.

LTM and cap maintenance will continue. In FY06, USMA will propose to regulators to reduce sampling frequency to every five years.

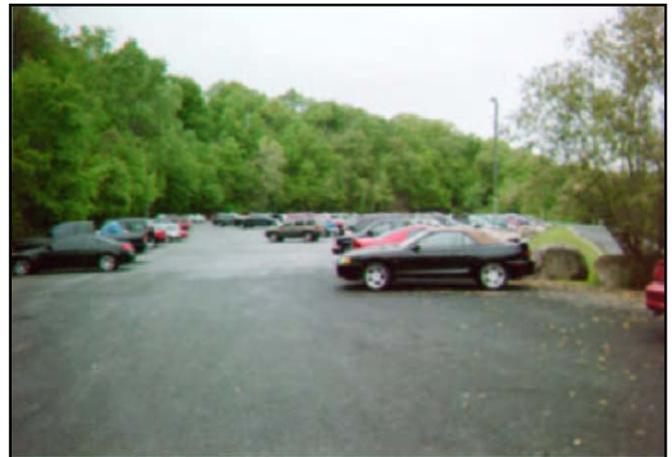
The Michie Stadium Lot F Landfill, which was part of the 6 Landfill Investigation Report, is located southwest of Michie Stadium; access is from Stony Lonesome Road. This three-acre landfill was used primarily in 1965. The pit and trench methods were used. The landfill is closed and paved. The site is now used as a parking lot. Leachate seeps have been identified at this site in the past and a leachate collection system was installed in FY01. Currently, the system is being evaluated for effectiveness. A storm water upgrade project was completed in FY01. The Michie Stadium Lot F Landfill has been included in USMA's Sampling and Analysis Plan for LTM and maintenance and groundwater sampling is conducted at this site.

LTM and cap maintenance will continue. In FY06, USMA will propose to regulators to reduce sampling frequency to every five years.

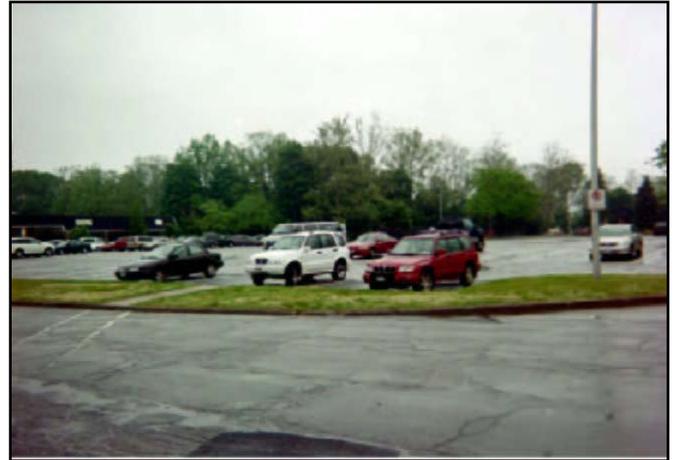
The Post Exchange (PX) Landfill is part of the 10 Landfill Investigation Report and is a 2-3 acre landfill located under the parking lot at the former Post Exchange. This was the installation landfill for domestic waste during the 1940s. The pit and area methods of landfilling were used at this location. The landfill is closed, covered and partially paved. The landfill is scheduled to be resurfaced in FY06. A parking lot and the former PX service station now cover part of the site. Although leachate seeps were observed at this site in the past, recent engineering inspections have detected no seeps.

NYSDEC requested additional sampling of this site in March 1998. The additional sampling was performed and a supplement to the 10 Landfill Investigation was submitted to NYSDEC in Jan 00. The supplement recommended no further action at the Landfill based on sample results. No decision document was prepared because no remedial action was required. The PX Landfill has been included in USMA's Sampling and Analysis Plan for LTM and maintenance and groundwater sampling is conducted at this site.

LTM will continue. In FY06, USMA will propose to regulators to reduce sampling frequency to every five years.

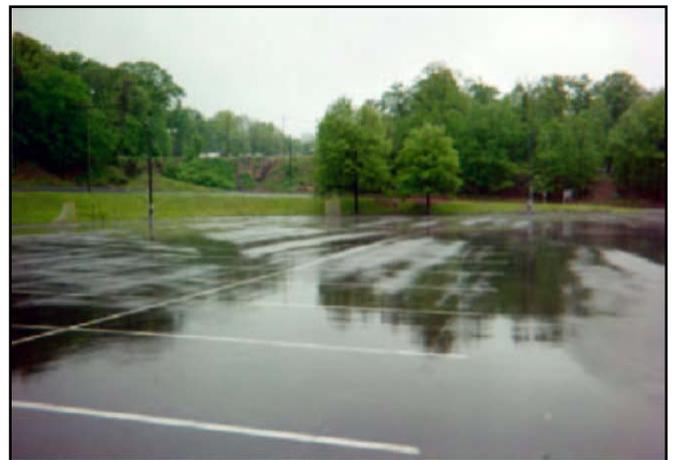
The Michie Stadium Lot A Landfill is part of the 10 Landfill Investigation Report and is located west of Michie Stadium. This 0.6-acre landfill was used approximately from 1952-1954. The pit and trench methods were used. The landfill is closed and partially paved. A cap and drainage system improvements were constructed in FY02. The site is now used as a parking lot. Although leachate seeps were observed at this site in the past, recent engineering inspections have detected no seeps. Restoration of the landfill cap was completed in FY03.

LTM and cap maintenance will continue. In FY06, USMA will propose to regulators to reduce sampling frequency to every five years.

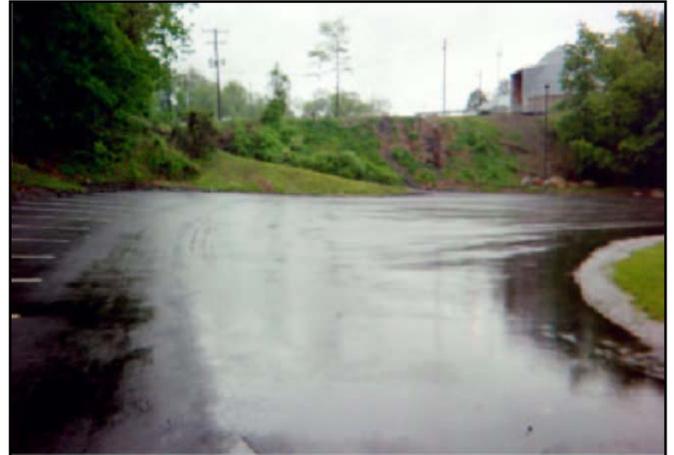
Michie Stadium Lot B Landfill

The Michie Stadium Lot B Landfill, which was part of the 10 Landfill Investigation Report, is located west of Michie Stadium; access is from Stony Lonesome Road. This 0.3-acre landfill reportedly received refuse in 1954. The pit and trench methods were used. The landfill is closed and partially paved. A cap and drainage system improvements were constructed in FY02. The site is now used as a parking lot. Although leachate seeps were observed at this site in the past, recent engineering inspections have detected no seeps. Restoration of the landfill cap was completed in FY03.

LTM and cap maintenance will continue. In FY06, USMA will propose to regulators to reduce sampling frequency to every five years.

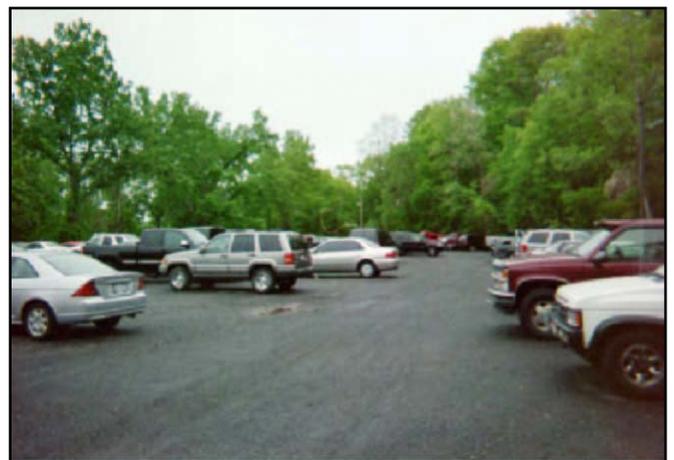
The Michie Stadium Lot C Landfill, was part of the 10 Landfill Investigation Report and is located west of Michie Stadium; access is from Stony Lonesome Road. This 1.6-acre landfill was used approximately between 1955 and 1956. The pit and trench methods were used. The landfill is closed and partially paved. The site is now used as a parking lot. The landfill is scheduled to be resurfaced in FY04. Although leachate seeps have been identified at this site in the past, recent engineering inspections have detected no seeps.

A storm water upgrade project was completed in FY01 to reduce cap deterioration and manage storm water run-off to prevent infiltration of water into the landfill mass. The Michie Stadium Lot C Landfill has been included in USMA's Sampling and Analysis Plan for LTM and maintenance and groundwater sampling is conducted at this site. LTM and cap maintenance will continue. In FY06, USMA will propose to regulators to reduce sampling frequency to every five years.

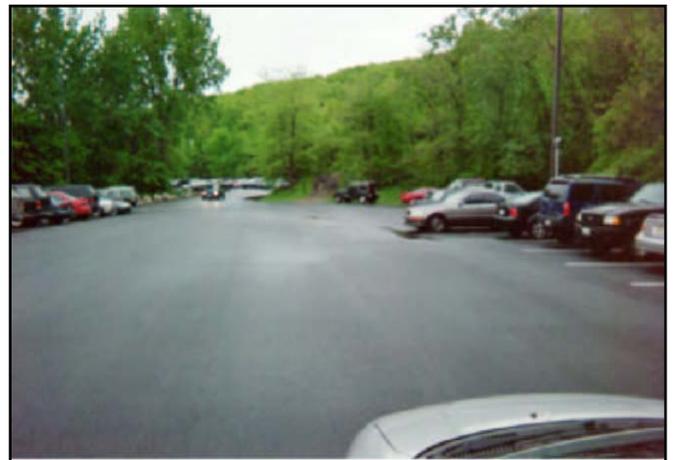
The Michie Stadium Lot E Landfill, which was part of the 10 Landfill Investigation Report, is located west of Michie Stadium; access is from Stony Lonesome Road. This four-acre landfill was used approximately from 1952 - 1954. The pit and trench methods were used. The landfill is closed and partially paved. The site is now used as a parking lot. A cap and drainage system improvements were constructed in FY02. Leachate seeps have been identified at this site in the past and a leachate collection system was installed in FY01. Currently, the system is being evaluated for effectiveness.

A cap and drainage improvement design was initiated in FY 96 and was completed in FY99. A storm water upgrade project was completed in FY01. The Michie Stadium Lot E Landfill has been included in USMA's Sampling and Analysis Plan for LTM and maintenance and groundwater sampling is conducted at this site.

LTM and cap maintenance will continue. In FY06, USMA will propose to regulators to reduce sampling frequency to every five years.

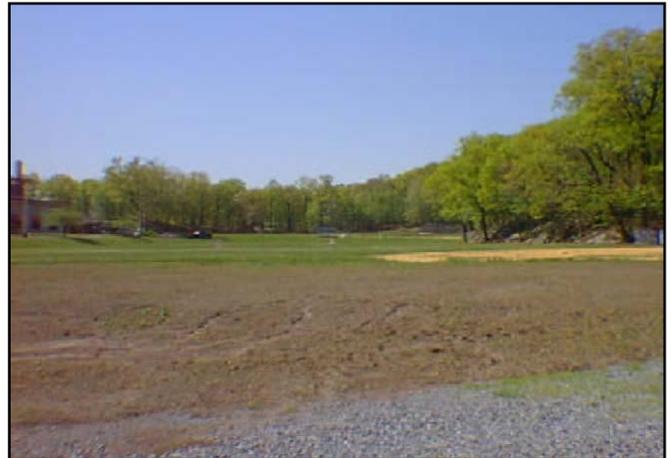
High School Landfill

The High School Landfill, which was part of the 10 Landfill Investigation Report, is located on land deeded to the Town of Highlands School District (approximately five miles from the main post); access is from Morgan Farm Road and Route 9W. The landfill consists of two separate fill areas: (1) the playing field, west of the school building, and; (2) the track, southeast of the school building.

Although the landfill is located on land deeded to the Town of Highland Falls School District, USMA as Primary Responsible Party for disposal of waste at the landfill is required to maintain the site in the IRP LTM Program.

LTM and cap maintenance will continue. In FY06, USMA will propose to regulators to reduce sampling frequency to every five years.

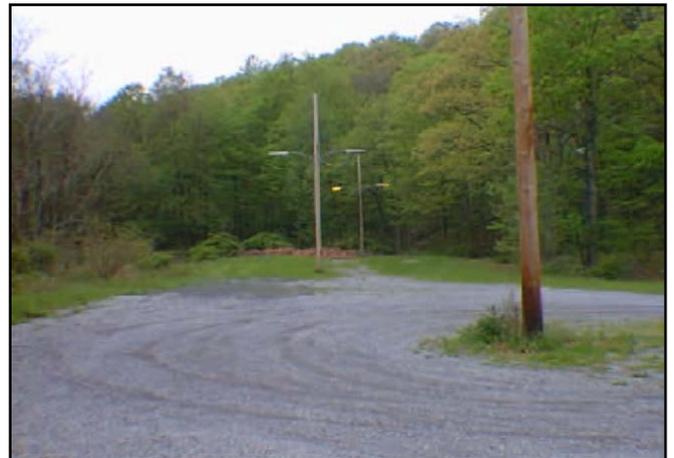
The Camp Buckner Landfill was part of the 10 Landfill Investigation Report and is located in the reservation area of the installation, at Camp Buckner. Access is from Patton Road, the main road into Camp Buckner, which intersects with Route 293. This 1.3-acre landfill was used in the 1970s and determined to be composed of construction and demolition debris. There are two small ponds north of the landfill; one is adjacent to the landfill and the other is approximately 150 feet from the landfill. The landfill is closed and covered with packed gravel and stone. The site is now used as a parking lot.

The Camp Buckner Landfill has been included in USMA's Sampling and Analysis Plan for LTM and maintenance and groundwater sampling is conducted at this site.

LTM and cap maintenance will continue. In FY06, USMA will propose to regulators to reduce sampling frequency to every five years.

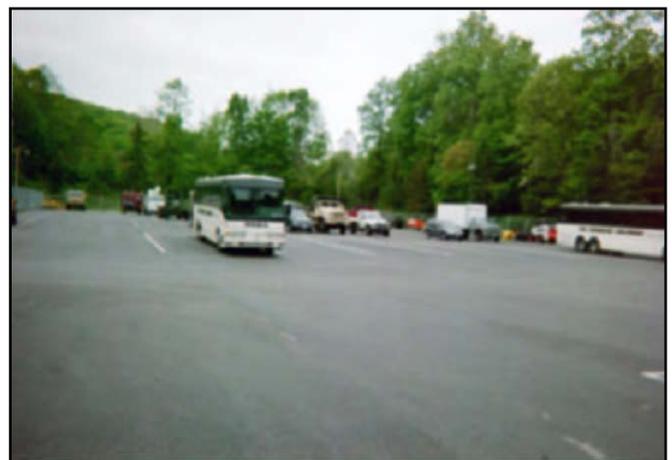
The Motor Pool East Landfill, which was part of the 4 Landfill Investigation Report, is located west of the Motor Pool Maintenance Buildings (Building 793/795). This 1.7-acre landfill was operated from 1964 to 1969 and reportedly received construction and demolition debris on its north side and sanitary waste on its south side.

The landfill was covered and paved in 2002. The site is now used as a parking lot by the Motor Pool. During construction of the cover, a leachate seep was observed emanating from the site. A cap and drainage system improvements were designed, constructed and completed in FY02. The Motor Pool East Landfill has been included in USMA's Sampling and Analysis Plan for LTM and maintenance and groundwater sampling is conducted at this site.

LTM and cap maintenance will continue. In FY06, USMA will propose to regulators to reduce sampling frequency to every five years.

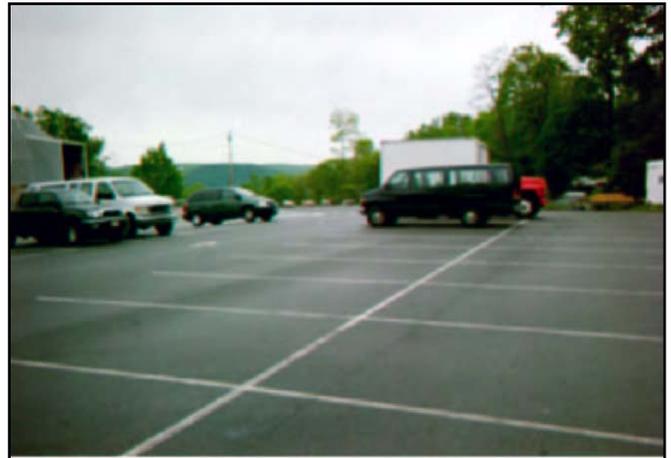
The Bldg. 706 Parking Lot Landfill, was part of the 4 Landfill Investigation Report, is located next to Building 706 (Maintenance Facility); access is from Stony Lonesome Road. The period of usage is unknown but is probably in the 1952-1956 time frame, based on surrounding sites (Michie Stadium Lots A-C). The one-acre landfill is now closed and paved and as a parking lot. The landfill was resurfaced with asphalt in FY01. The Bldg. 706 Parking Lot Landfill has been included in USMA's Sampling and Analysis Plan for LTM and maintenance and groundwater sampling is conducted at this site.

LTM and maintenance will continue. In FY06, USMA will propose to regulators to reduce sampling frequency to every five years.
