Final Environmental Assessment

**Family Housing Rehabilitation
U.S. Army Garrison West Point
West Point, Orange County, New York**

**United States Army Garrison West Point
West Point, New York**

October 2005

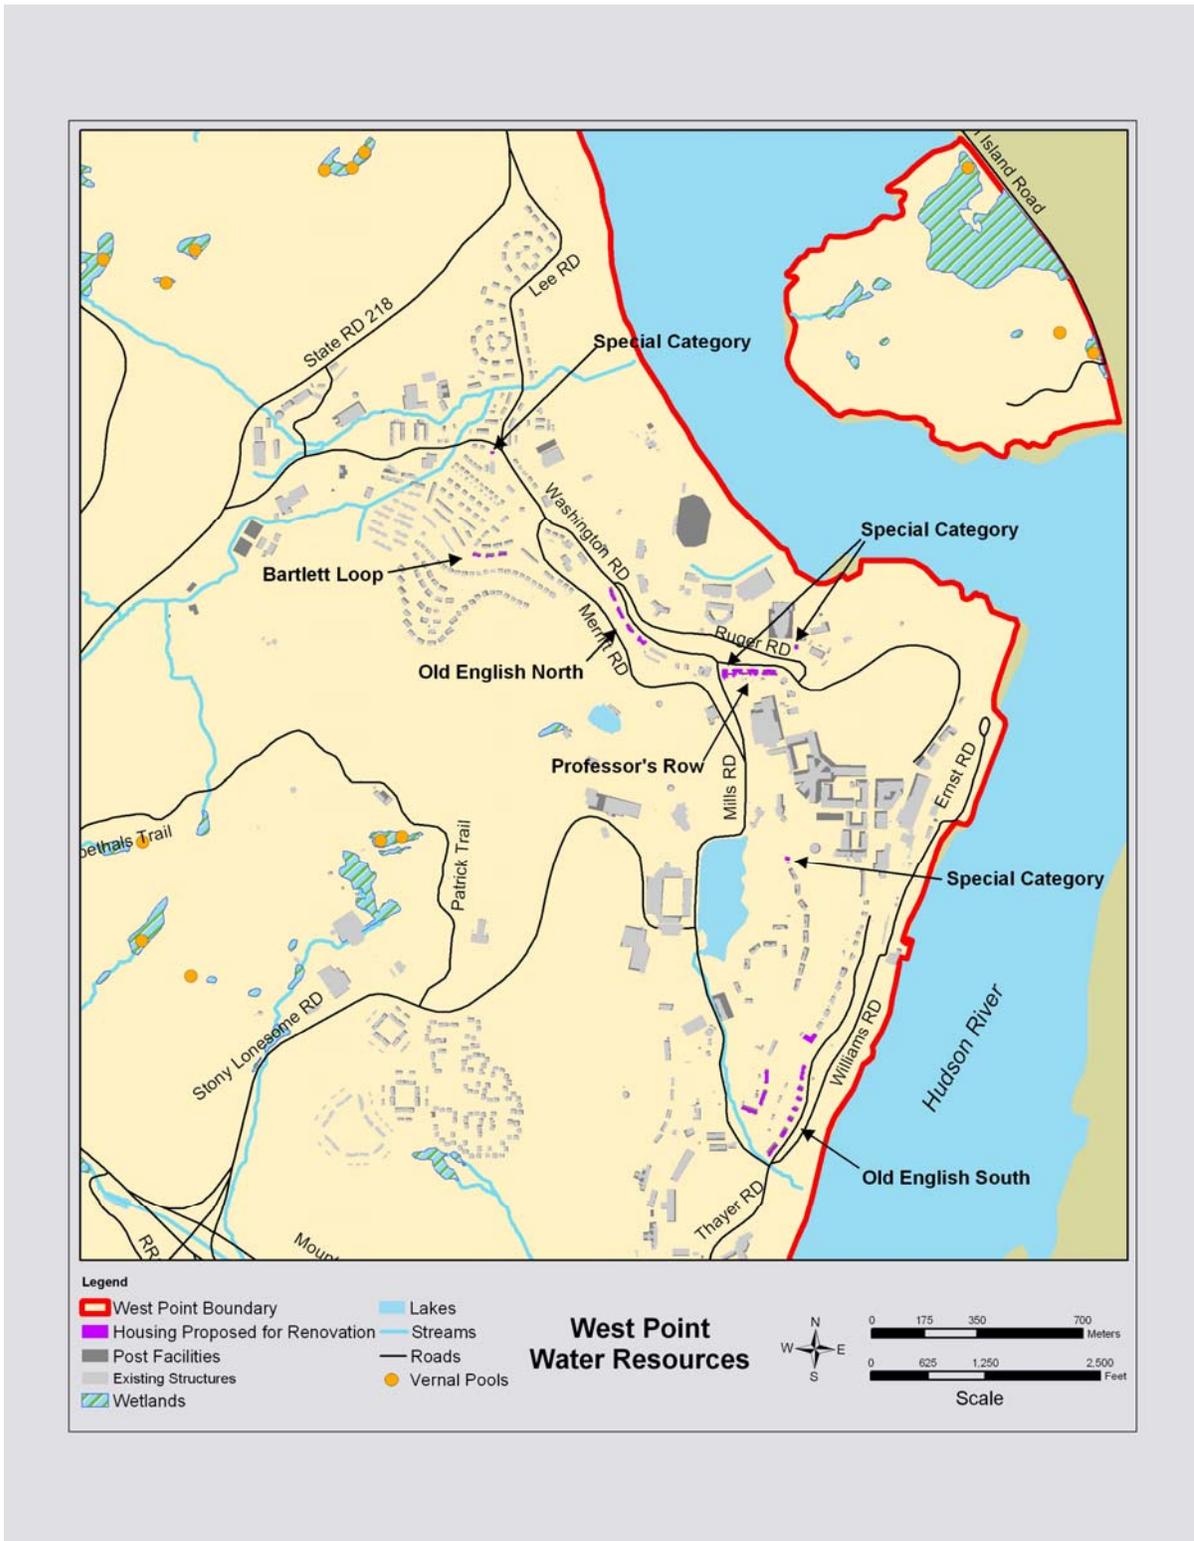
FIGURE 2-1: WEST POINT WATER RESOURCES

In addition to the Hudson River, numerous lakes, ponds, and streams are located throughout West Point. Many of the lakes and ponds were formed from artificial dams that have raised water levels within former wetland areas. Figure 2-1 shows water resources on the Main Post of West Point. Surface water features near each housing area are listed below, with distance to the Hudson River noted:

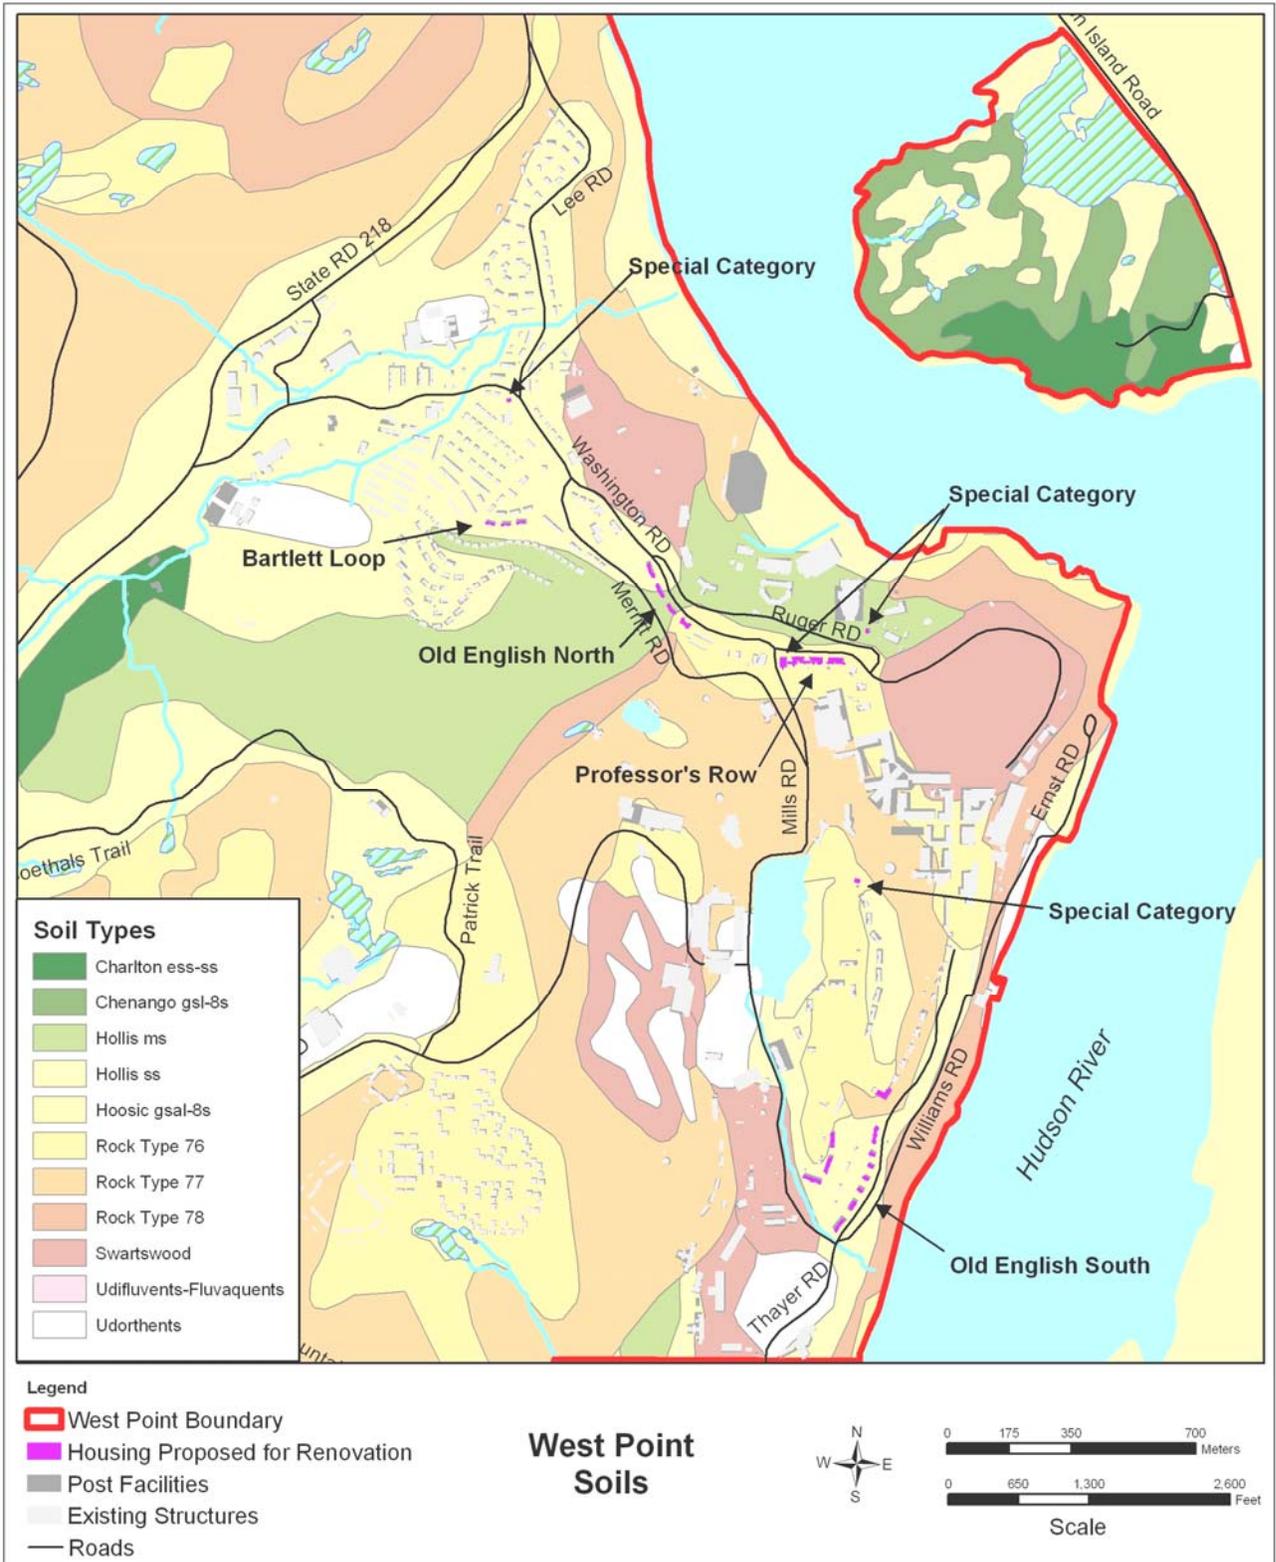
FIGURE 2-4: WEST POINT SOILS

In the Soil Survey of Orange County, the Hollis-Rock Outcrop map unit is described as, “mostly forested, good habitat for wildlife and unsuited to farming or community development. The soils are shallow and are well-drained to excessively-drained. The rate of water movement is moderate or moderately rapid” (USDA SCS, 1981). The Orange County Soil Survey shows 43 mapping units on West Point. Soils on the Main Post at West Point are shown in Figure 2-4. In the proposed project areas, much of the proposed work will occur on previously cut and filled areas, and not on native soils. Soils in the area of each family housing area are discussed below:

- Hollis soils, sloping (HLC) – This mapping unit is classified as shallow, well-drained to somewhat excessively-drained, and sloping and gently sloping. These soils were formed in glacial till deposits derived from crystalline rock that is dominantly schist, gneiss, and granite. This unit is found on hillcrests, hilltops, valley sides, and ridges of the mountainous uplands. Most areas with this unit are either idle or forests, with a few pastured or used for hay. This unit usually does not have a perched water table above the bedrock and has moderate to moderately rapid permeability. Available water capacity is very low or low, runoff is medium to rapid, and bedrock is at a depth of 10 to 20 inches (25 to 51 cm). This unit is limited for most crops and is poorly suited to most urban and recreation uses because of the shallowness over bedrock and associated dryness. Deep excavation is very difficult as a result of the hardness of the underlying rock. This unit has severe limitations for the development of dwellings with or without basements, local roads and streets, shallow excavations, small commercial buildings, and lawns and landscaping.

- Rock outcrop-Hollis complex, sloping (ROC) – This unit is composed of exposed bedrock and the shallow, somewhat excessively drained to well drained Hollis soils. The ROC unit can be found on hillcrests, hilltops, and ridges of the mountainous uplands. There is no free water perched above the bedrock in this unit, except where the rock is poorly jointed. This unit has moderate or moderately rapid permeability, low or very low water capacity, medium to rapid runoff, and a bedrock depth of 10 to 20 inches (25 to 51 cm). This complex of rock and soil is not suited to crop production, timber production, or urban uses. This unit has severe limitations for the development of dwellings with or without basements, local roads and streets, shallow excavations, small commercial buildings, and lawns and landscaping.

Old English South: The soil mapping unit found within the Old English South Housing Unit includes Hollis soils (HLC). The properties of this unit are described above.

Professor's Row: Soil units at Professor's Row is composed of Rock outcrop-Hollis complex, moderately steep (ROD). This unit is composed of exposed bedrock and the shallow, somewhat excessively-drained to well-drained Hollis soils. The ROD unit can be found on hillcrests, hilltops, and ridges of the mountainous uplands. There is no free water perched above the bedrock in this unit, except where the rock is poorly jointed. This unit has moderate or moderately rapid permeability, low or very low water capacity, rapid to very rapid runoff, and a bedrock depth of 10 to 20 inches (25 to 51cm). Most areas of this unit are forested with sparse plant cover in areas of exposed bedrock. This complex of rock and soil is not suited to crop production, timber production, or urban uses. This unit has severe limitations for the development of dwellings with or without basements, local roads and streets, shallow excavations, small commercial buildings, and lawns and landscaping.

Bartlett Loop: The soil mapping unit found around the Bartlett Loop includes the Hollis soils. The properties of this unit are described above.

Special Category Quarters: The soil mapping units found within the Special Category Quarters Housing Units includes the Hollis soils (HLC and HLD), Rock outcrop-Hollis complex, moderately steep (ROD), and Rock outcrop-Hollis complex, sloping (ROC). The properties of this unit are described above.

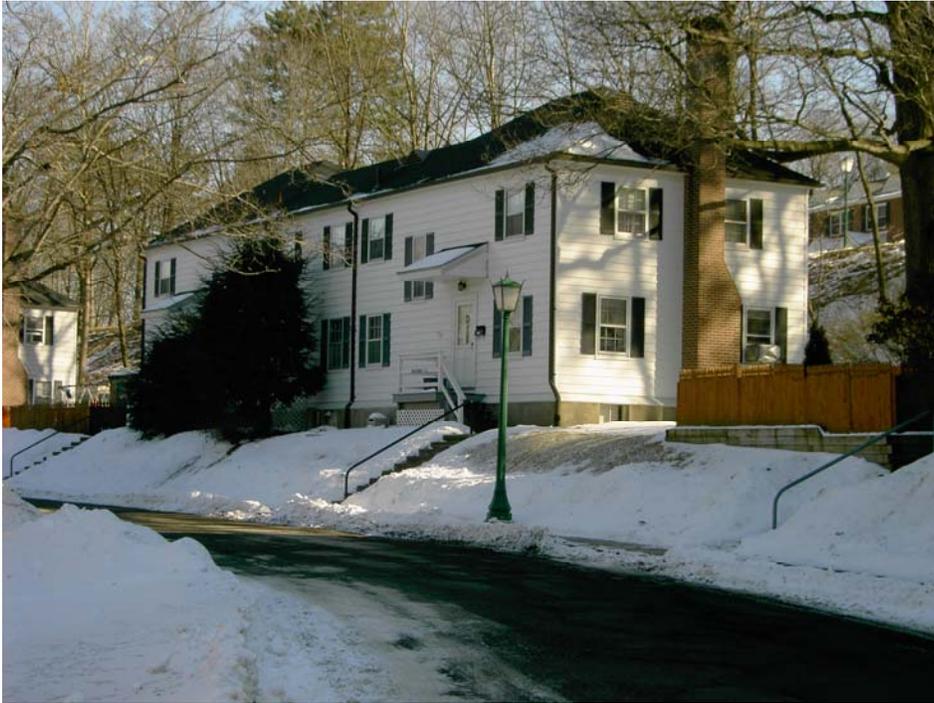
FIGURE 2-5: BARTLETT LOOP HOUSING - NON-HISTORIC QUARTERS

For the reasons stated above, the Bartlett Loop Quarters (Quarters 128, 130, and 132), displayed in Figure 2-5, do not appear to retain sufficient degrees of historic fabric or architectural character, nor do they possess a demonstrable architectural significance requisite for National Register eligibility or contributing status to the NHLD. As a result, the Bartlett Loop Quarters 128, 130, and 132 are not be considered individually eligible for the National Register and are no longer be considered contributing elements of the NHLD. Proposed work in these buildings would not alter any of the characteristics that qualify USMA as a NHLD and therefore would have no adverse effect on the NHLD Figure 2-6, Figure 2-7, Figure 2-8, and Figure 2-9 show and example of the historic family housing units to be renovated under the Proposed Action.
